# EKATI DIAMOND MINE

ENVIRONMENTAL AGREEMENT AND WATER LICENCE

ANNUAL REPORT SUMMARY 2019

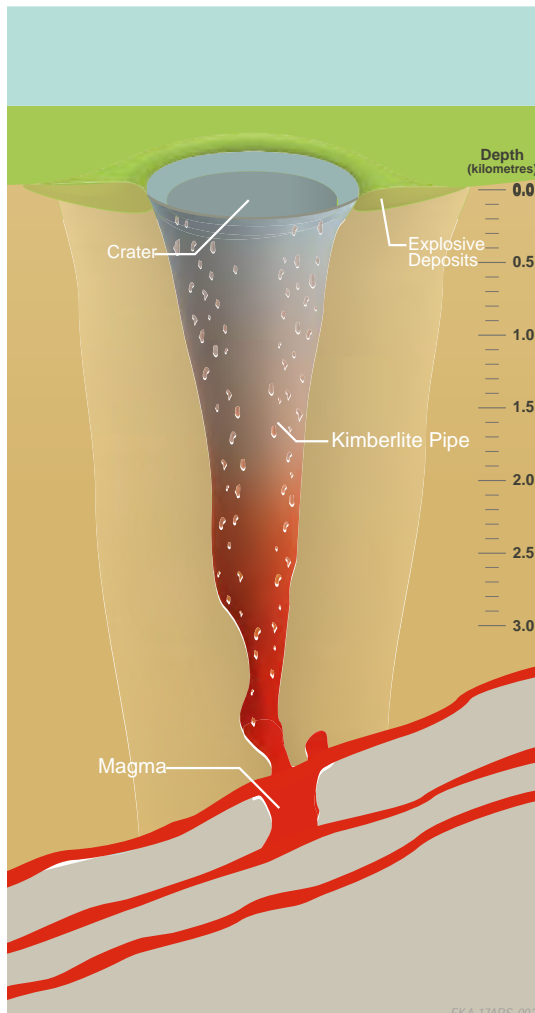
**Figure 2**  
Structure of a kimberlite pipe.

At the Ekati Diamond Mine, miners use two methods to remove the diamond-rich kimberlite ore from the ground: open pit mining and underground mining. In open pit mines, workers remove waste rock and earth to get to the kimberlite pipe using digging equipment and explosives. In underground mines, spiral-shaped tunnels are built to allow mining equipment to drill, blast, dig, and haul the ore from deeper parts of the kimberlite pipes.

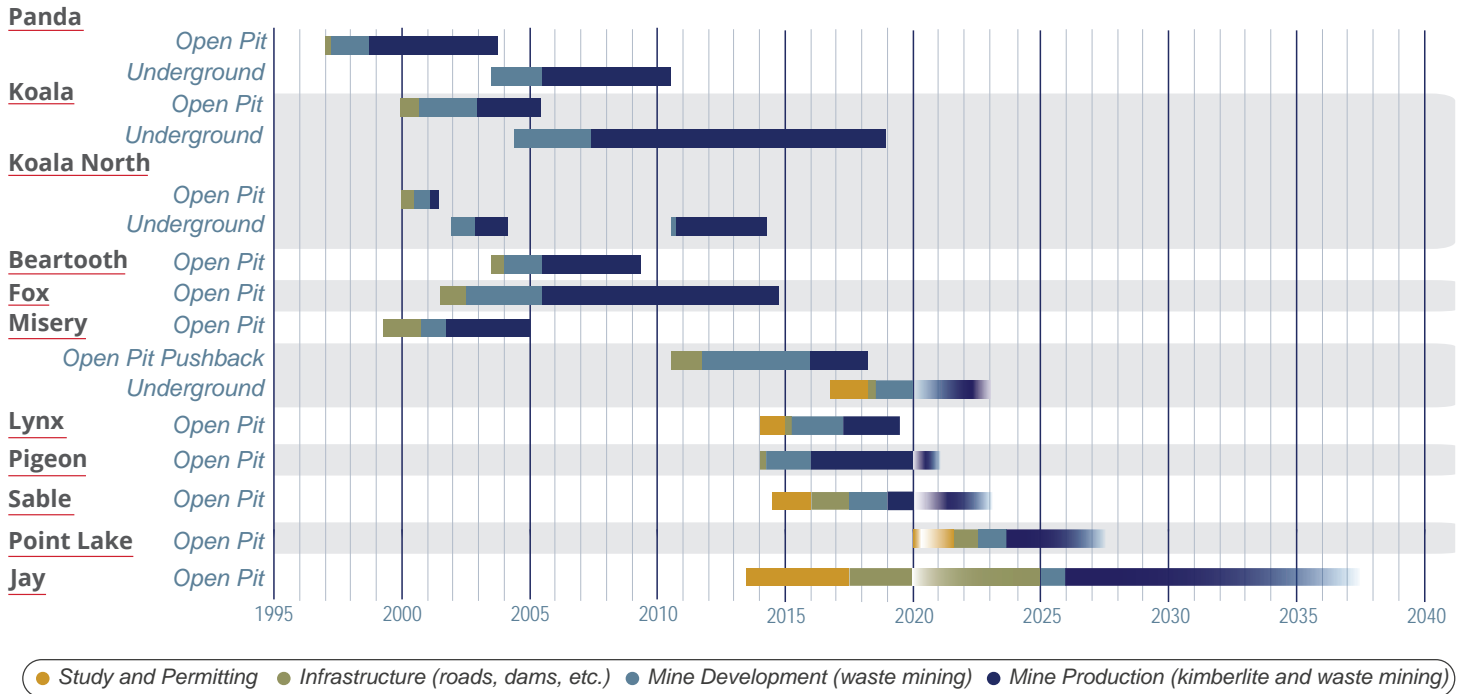
**Figure 3**  
Ekati life of mine plan

Note:  
 \*Point Lake is currently in the pre-feasibility stage and is not currently permitted.

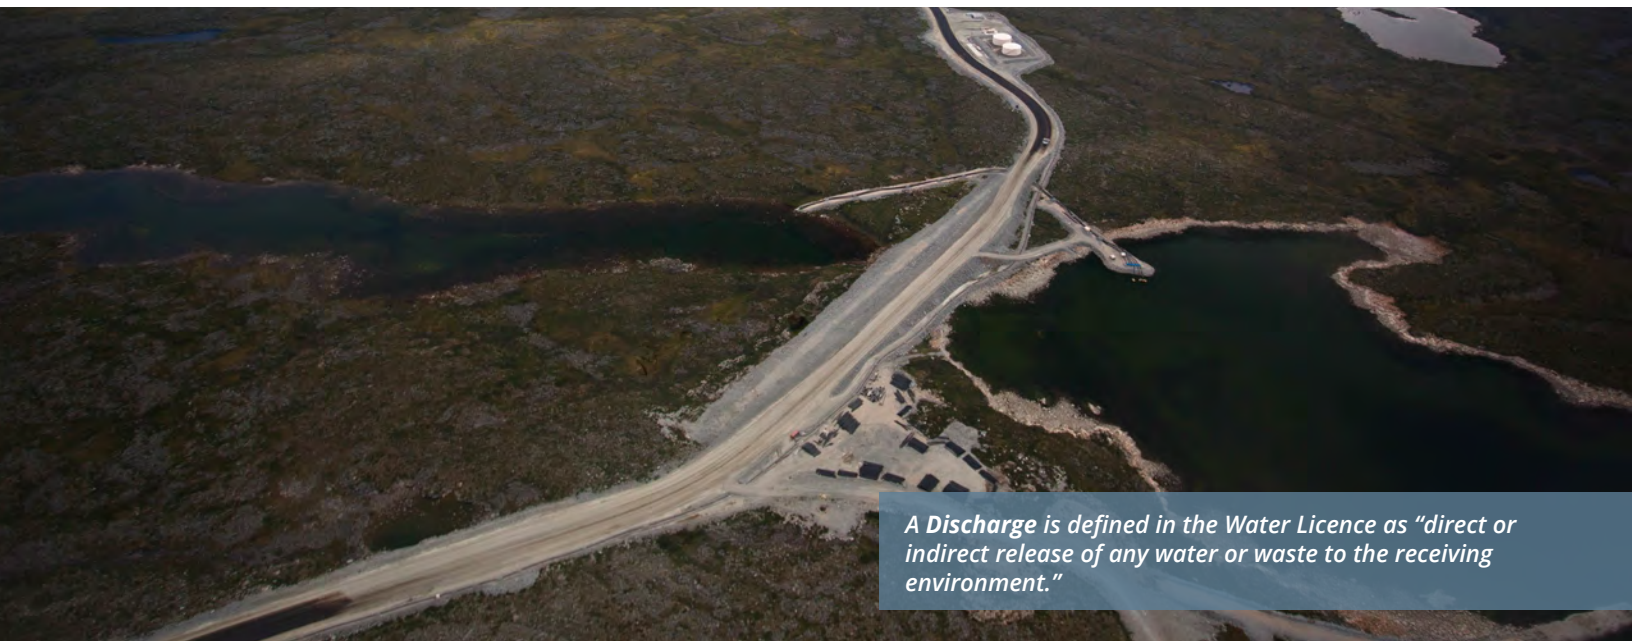
Discharge point between Long Lake Containment Facility (right) and Leslie Lake (left)

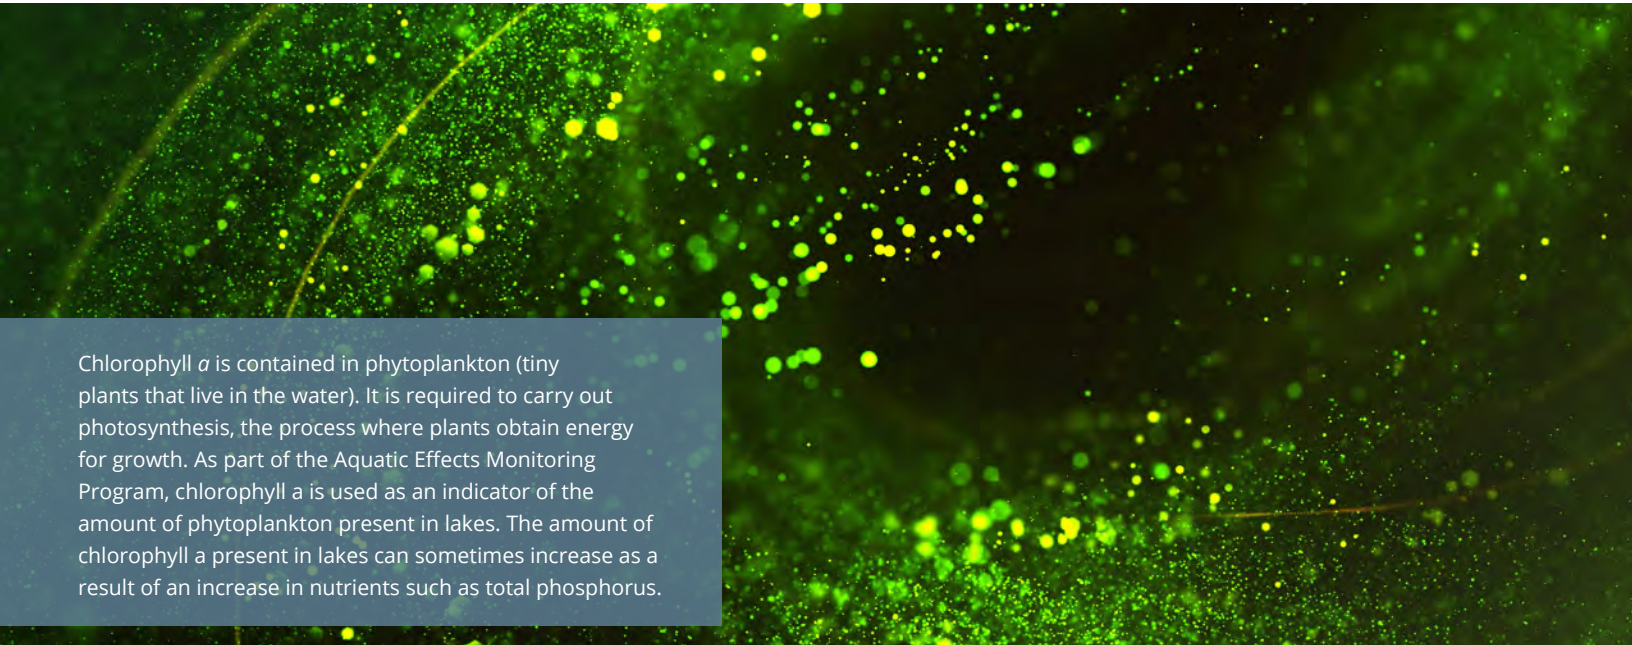
Figure 7 (continued)  
 Summary of Water Quality and Biological Changes in the Koala Watershed and Lac de Gras

Grizzly Lake	Lower PDC	Kodiak Lake	Kodiak-Little Stream	LLCF Leslie Lake	Leslie-Moose Stream	Moose Lake	Moose-Nero Stream	Nema Lake	Nema-Martine Stream	Slipper Lake	Slipper-Lac de Gras Stream	Lac de Gras S2	Lac de Gras S3	Lac de Gras S5	Lac de Gras S6
<b>Phytoplankton</b>																
Chlorophyll a	●	==	⊕	==	⊕	==	⊕	==	⊕	==	⊕	==	⊕	●	==	==
Total density	●	==	⊕	==	⊕	==	⊕	==	⊕	==	⊕	==	●	●	==	==
Edible density	●	==	●	==	●	==	●	==	●	==	●	==	●	●	==	==
Non-edible density	●	==	●	==	●	==	●	==	●	==	●	==	●	●	==	==
Diversity	●	==	●	==	●	==	●	==	●	==	●	==	●	●	==	==
Community composition	●	==	●	==	●	==	●	==	●	==	●	==	●	●	==	==
<b>Zooplankton</b>																
Total biomass	●	==	●	==	●	==	●	==	●	==	●	==	●	●	==	==
Total density	●	==	●	==	●	==	●	==	●	==	●	==	●	●	==	==
Rotifer density	●	==	●	==	●	==	●	==	●	==	●	==	●	●	==	==
Adult crustacean density	●	==	●	==	●	==	●	==	●	==	●	==	●	●	==	==
Diversity	●	==	●	==	●	==	●	==	●	==	●	==	●	●	==	==

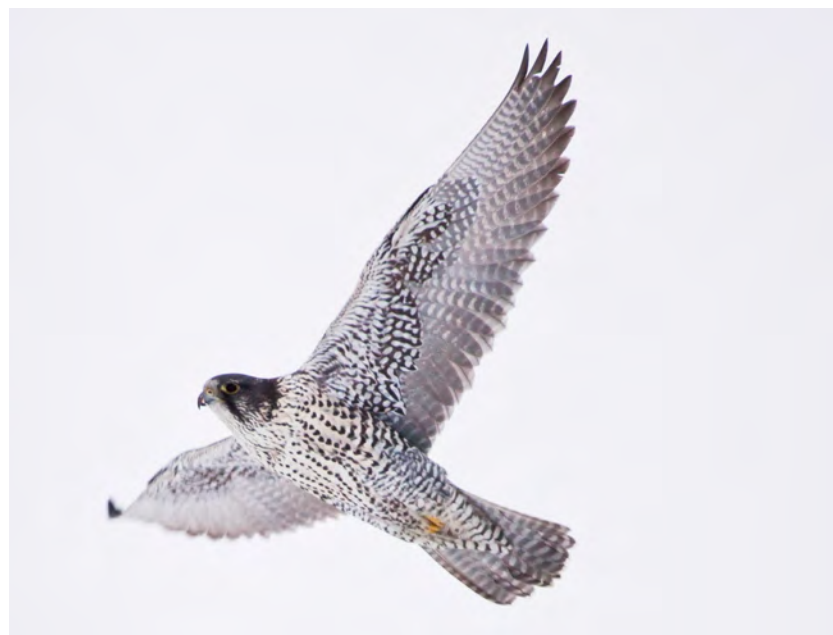
Figure 10  
 Number of Birds Spotted during the Ekati Diamond Mine Bird Survey 2003 to 2019

The North American Breeding Bird Survey (NABBS) was done for the 17th year at the Ekati Diamond Mine in 2019. The NABBS is a way of surveying birds that is conducted at over 400 locations across Canada. The data, which are compiled by the Canadian Wildlife Service, helps identify bird distribution and abundance across North America. During the survey, 409 individuals of 26 species were recorded. Five species of conservation concern were observed during the 2019 breeding bird survey: red-necked phalarope, long-tailed duck, Harris's sparrow, yellow-billed loon and northern pintail. Figure 10 shows trends for some of the more common birds observed at the mine site over the past 17 years.

See figure 10 on the next page for number of birds spotted during the Ekati Diamond Mine bird survey
